## SMITH-EMERY LABORATORIES

**CONCENTRATED LOAD TESTING ON  
PORCELAIN PAVERS (MODIFIED ASTM C293)**

43208-1

L15-1138

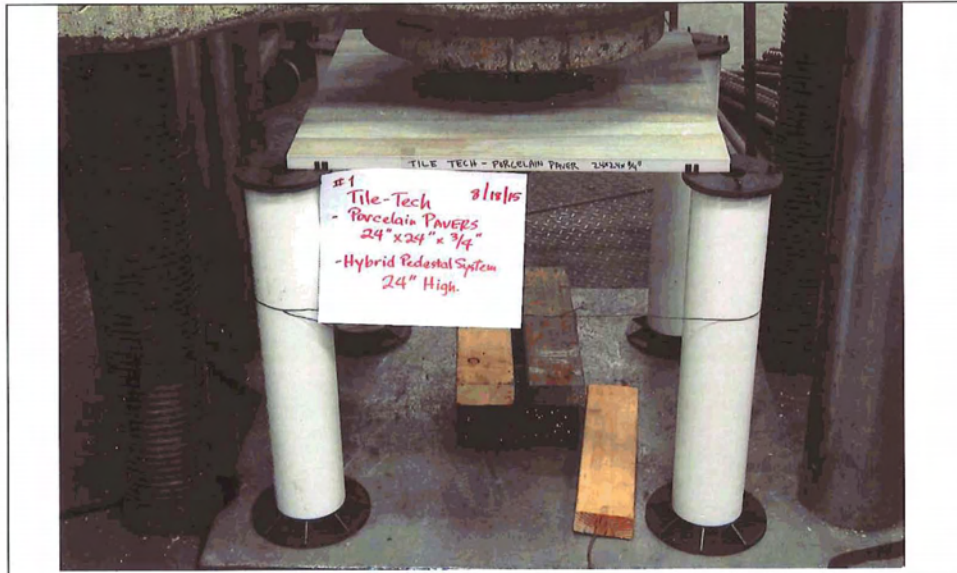
**Photo No. 1: General view of Porcelain Samples Setup**

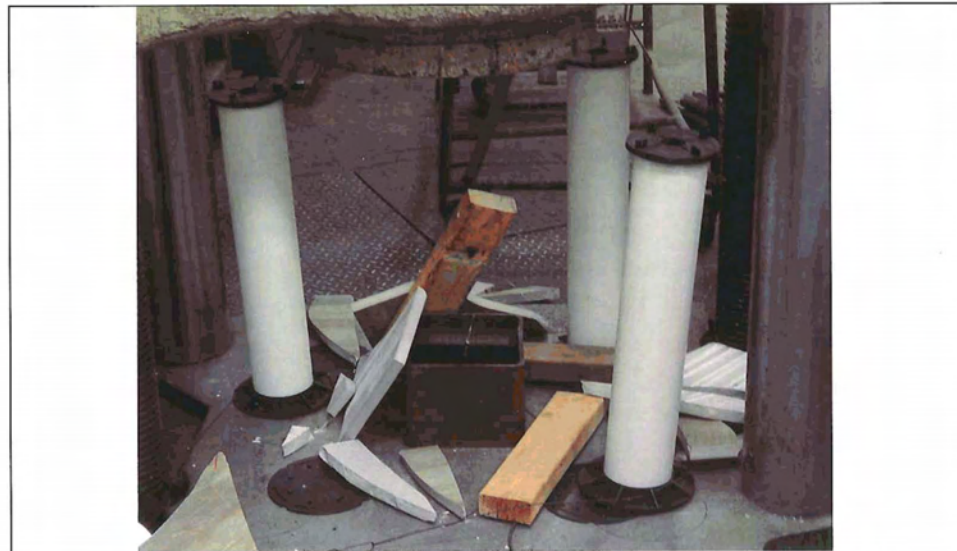
**Photo No. 2: General view of Porcelain Samples Failure**

Specimen	Maximum Load (lbs.)	Deflection at Max. Load (in.)	Remarks
S1	2,140	0.20	Paver cracked at the maximum load
S2	2,050	0.21	Paver cracked at the maximum load
S3	2,050	0.19	Paver cracked at the maximum load
Average	2,080	0.20

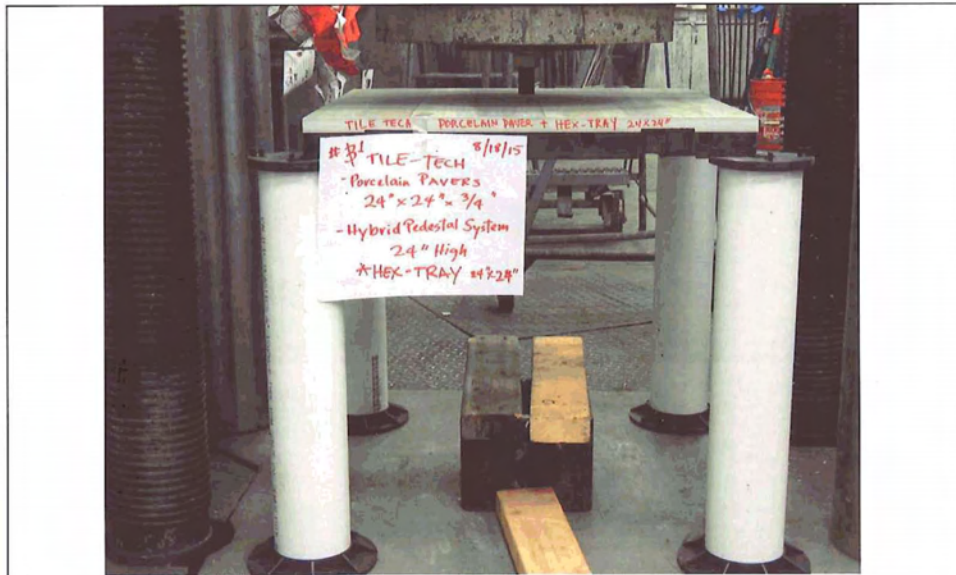
**Photo No. 3:** General view of Hex-Tray Sample Setup

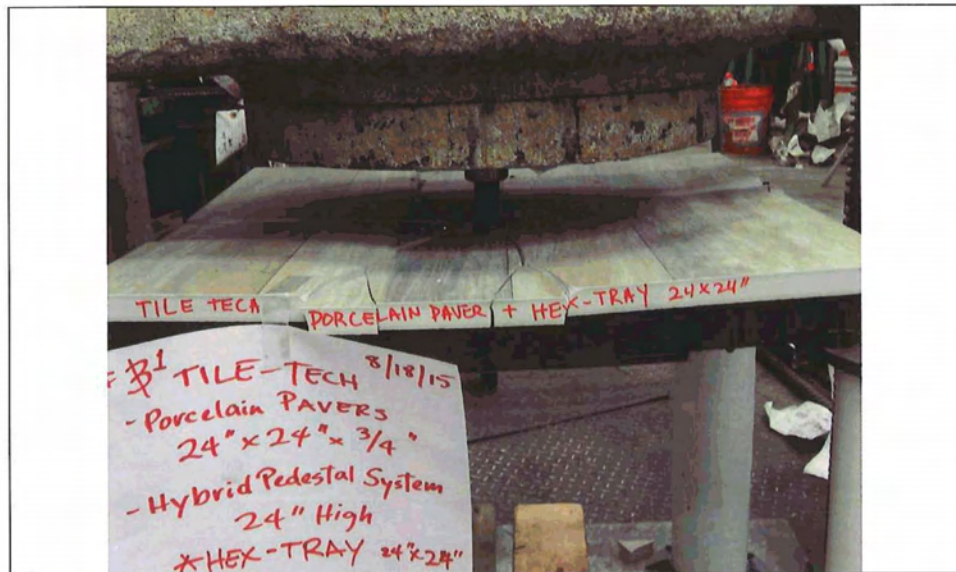
**Photo No. 4:** General view of Hex-Tray Sample Failure

Specimen	Maximum Load (lbs.)	Deflection at Max. Load (in.)	Remarks
S7	1,910	0.23	Paver cracked at the maximum load
